SIMPLEX MOORING  
UNDERWATER INSPECTION REPORT

JULY 1983

FPO 1 83(30)

CHESAPEAKE DIVISION  
NAVAL FACILITIES ENGINEERING COMMAND  
WASHINGTON NAVY YARD  
WASHINGTON, DC 20374

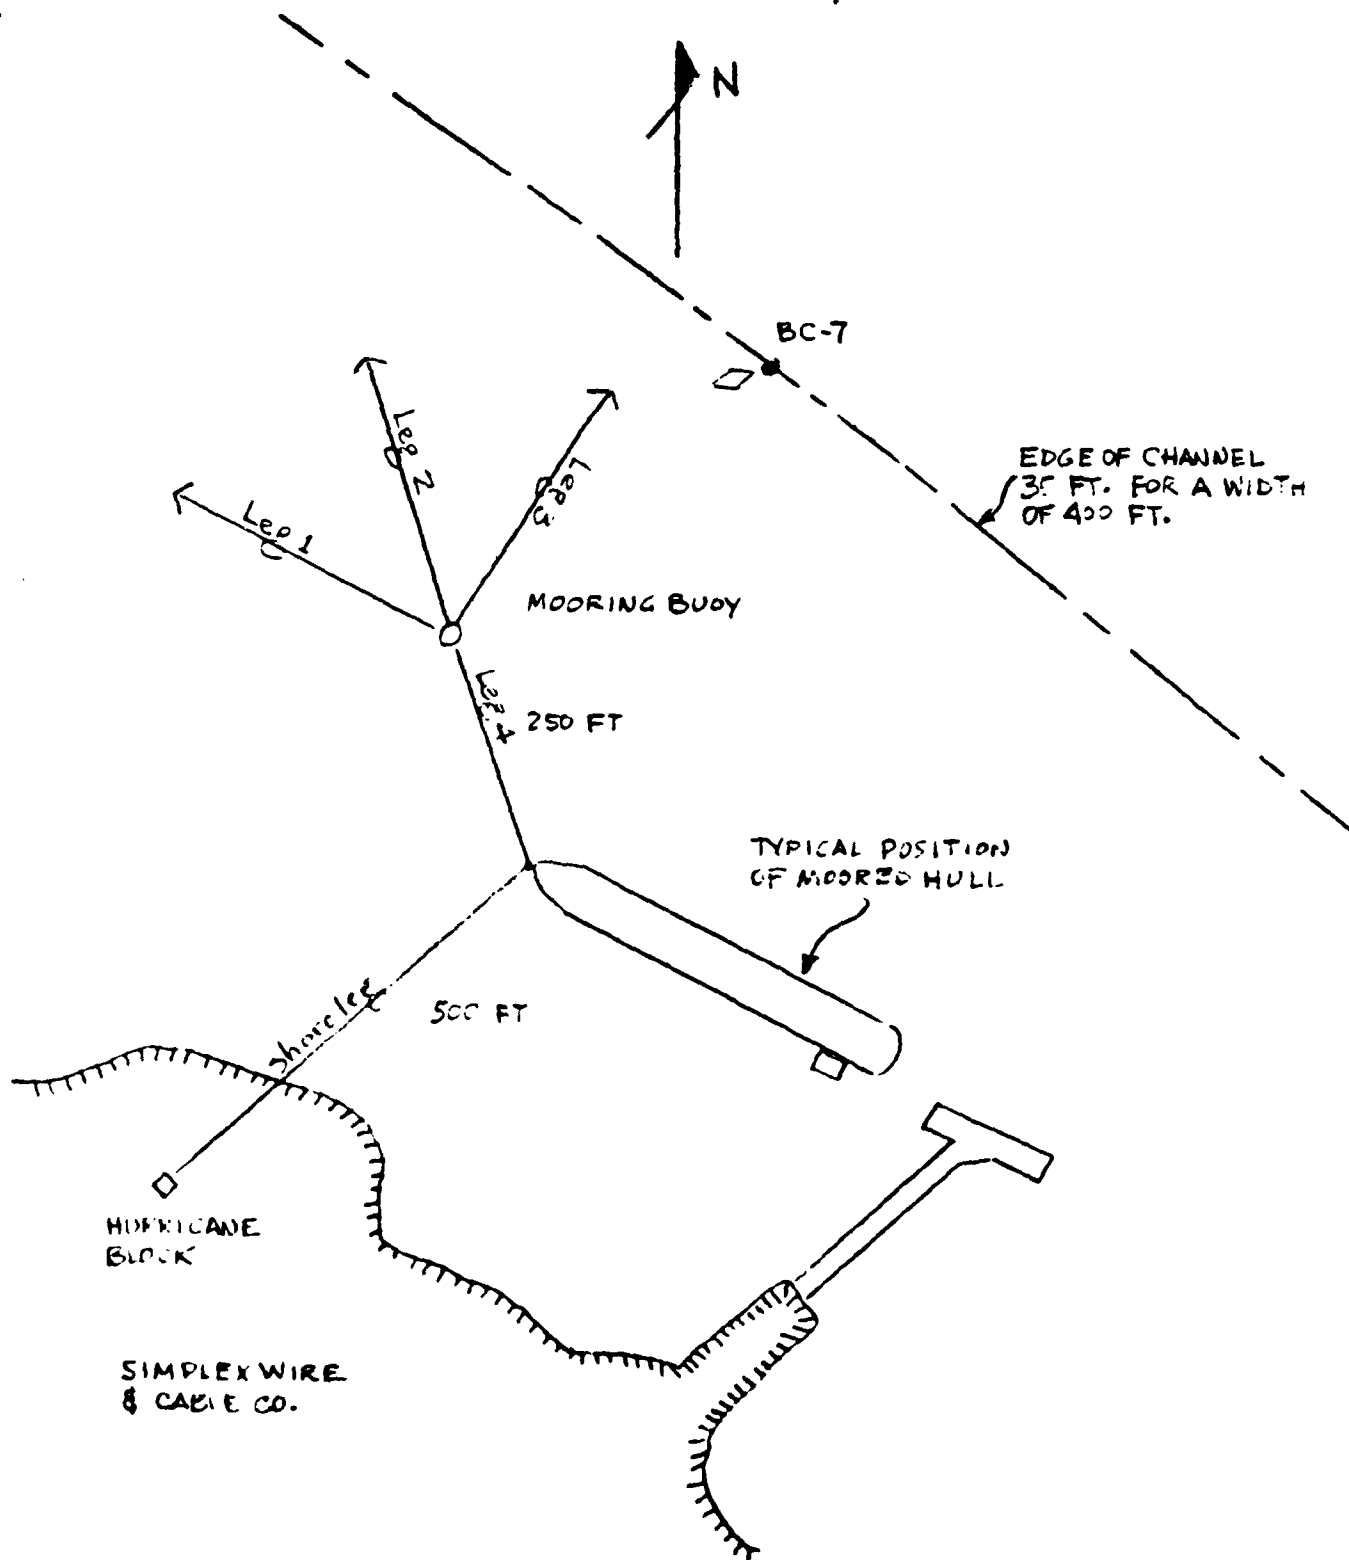
Figure 2

New points were established, as shown in Figure 5 and the locations of the mooring buoy and the anchors on legs 2 and 3 were determined with respect to these. The locations thus determined agree to within about 30 feet with those shown in Figure 2. It is concluded that no significant movement of the mooring has occurred.

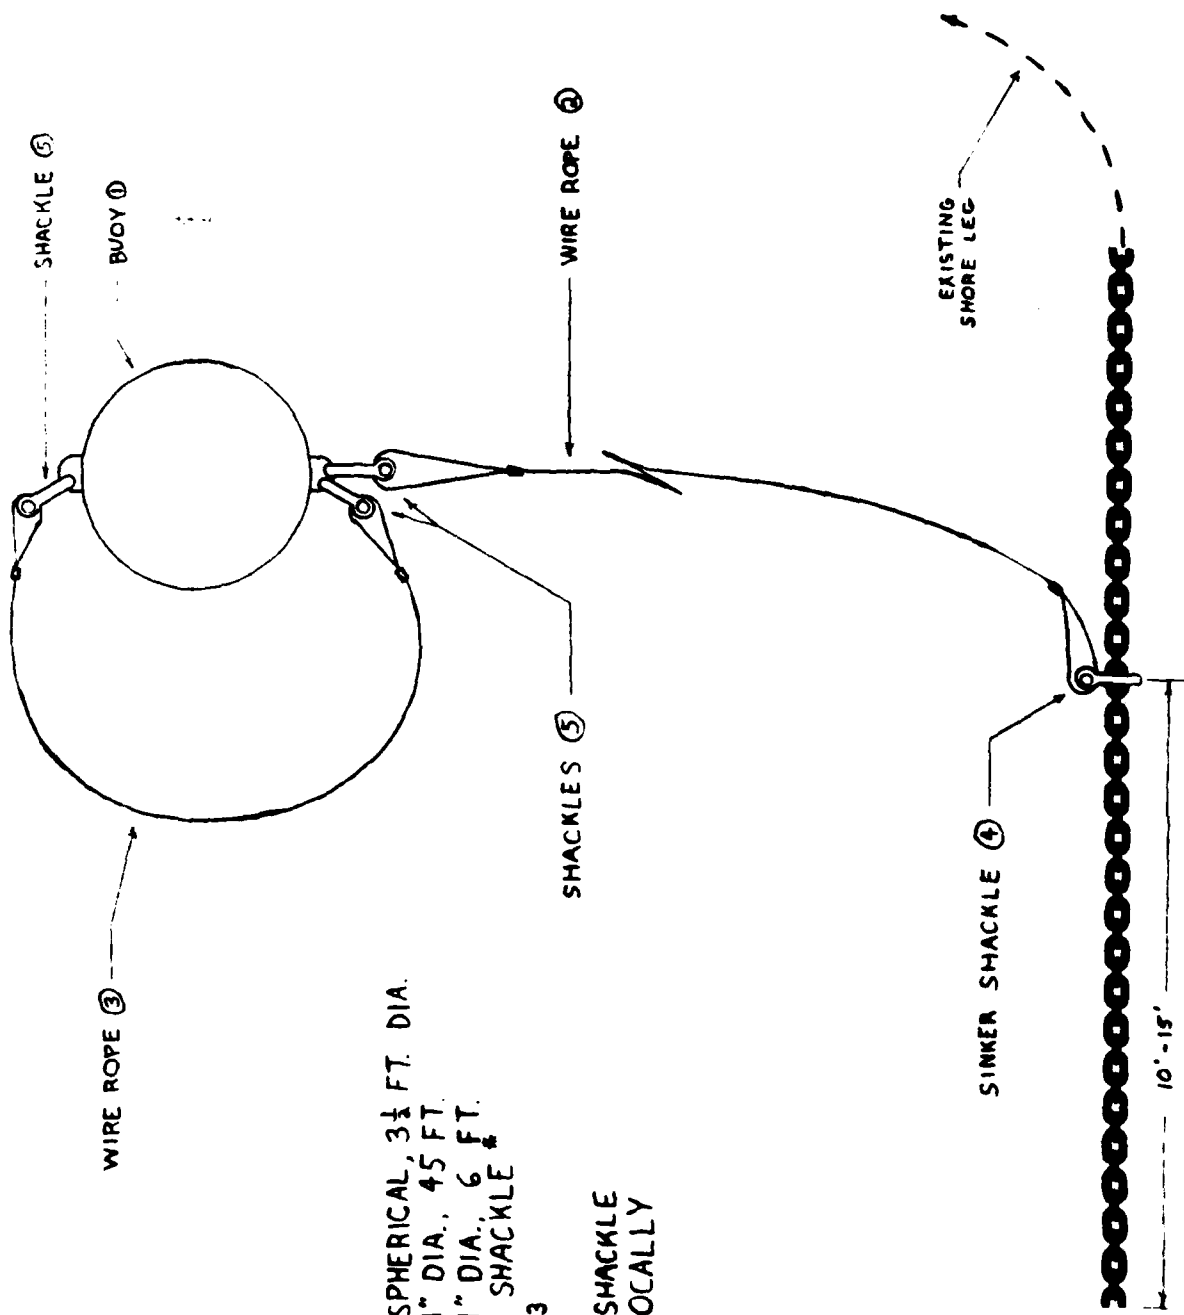
Figure 3

The shore leg consists of 455 feet of miscellaneous lengths of 2½-inch chain attached to a hurricane block on shore and laid on the bottom to a point near the mooring buoy. A riser wire and marker buoy attached near the end of the chain allow the end of the chain to be retrieved and attached to the port anchor chain of the vessel being moored. See Figure 3. As mentioned above, this assembly was missing and was replaced by the dive team. The pre-assembled marker buoy did not include a sinker shackle, so that it was necessary to fabricate one from a 3-inch anchor shackle. The Simplex welding shop performed this modification (Figure 4).

- o Users of the mooring should be encouraged to retain the marker and riser wire for the shore leg and to replace it on the shore leg before casting off the mooring.**
